**Departmental
investigation into
switchboard fire aboard
the Australian flag bulk
cement carrier Goliath at
Devonport, Tasmania on
23 August 1997**

investigation into the switchboard fire aboard the Australian flag
bulk cement carrier GOLIATH at Devenport Tasmania on 23 August 1997

Published: May 1997

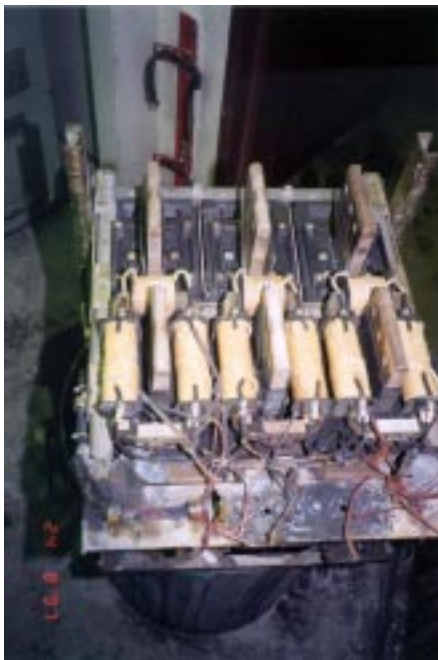
Fire damage No.2 ACB back C.T.'s on outgoing lines

The source of the fire appeared to be an internal fault in No.2 generator air circuit breaker. The circuit breaker for No.2 generator was manufactured by the Hyundai Electric Engineering Co. of Ulsan, Korea. The data plate carried the following details:

The fire destroyed the circuit breaker and its associated control equipment. Heat damage had affected the adjacent cubicles either side of No.2 cubicle. These cubicles contained the circuit breaker for No.1 generator and the generator synchronising panel. Neither No.1 generator, nor No.2 generator, could be connected and the synchronising panel was inoperative. The remainder of the main switchboard had suffered some smoke damage. See photographs pages

From the above observations, the source of the problem would be the overheating of the centre pole causing the insulating parts to ignite. The cause of the thermal failure of the centre pole is unknown.”

Following the fire, Lloyd’s Register of Shipping stipulated that the circuit breaker should be replaced by a complete new unit.

A considerable amount of PVC insulation on electrical cables was burned during the fire. When this occurs, highly corrosive hydrogen chloride is formed which must be promptly removed before severe corrosion affects components. Due to the extensive smoke damage, this operation would have necessitated the removal, disassembling, cleaning and testing of all the large circuit breakers in addition to any necessary repair work. As a result of both financial and risk management considerations, the owners and ship managers together decided to replace all of the ship’s air circuit breakers with AT15 and AT25 models manufactured by Terasaki in Japan.

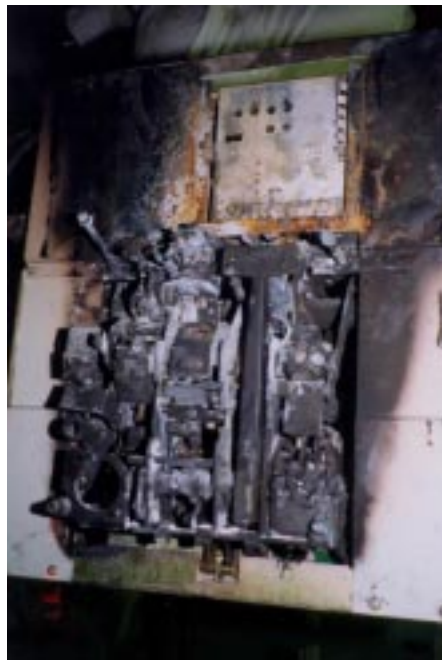
Fire Damage No.2 ACB view

Subsequent examination of the circuit breaker indicated, among other things, serious overheating of the copper leads to the soft start contactors and the overcurrent coil.

“The breaker is extensively damaged with the internal insulating parts having been completely consumed by fire. Damage to accessories mounted on the breaker and the wiring to them is extensive. The circuit breaker carriage has been damaged by the fire.

The main current carrying path of the circuit breaker is intact, but the centre pole shows signs of overheating. The plug-in contacts of the main circuit are in good condition (except for damage due to the fire).

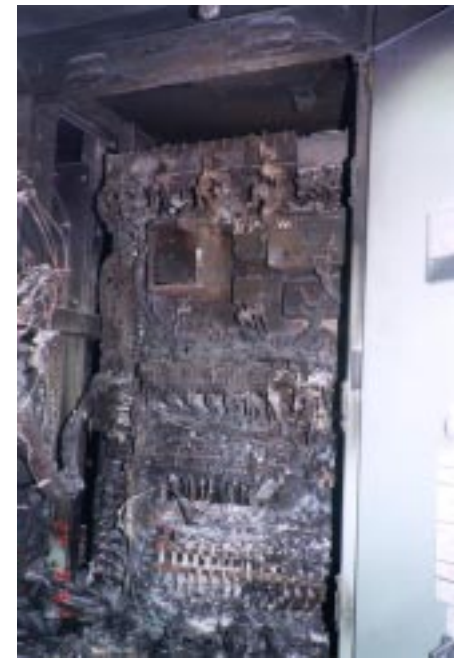
Fire damage No.2 D/G upper level

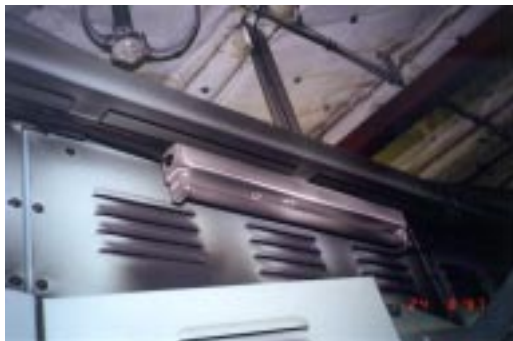
Heat detector above synchronising panel

A heat detector, part of the automatic fire detection system, was situated above the main switchboard, within one metre horizontally of the cubicle. It seems that the cubicle had limited the heat radiation by the fire and, although covered in soot, the detector had not operated during the incident. This detector was later tested and found to be operational.

4. A heat detector, located above, and very close to, the cubicle containing the No.2 generator circuit breaker proved ineffective at giving an early alarm as heat was contained largely within the cubicle and the main problem was the generation of large quantities of smoke from the insulation of cables.

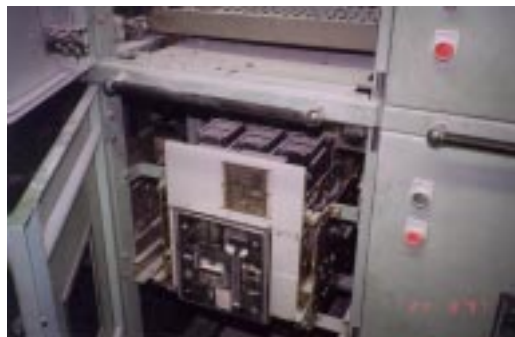
Hyundai type circuit breaker

Hyundai Electric Engineering Co. Ulsan, under licence to Terasaki, HAT 25 3-pole, 660 volt, 50-60 Hz, 2,500A, ambient temp. 45°C. LR approved

At the time of building, *Goliath’s* Hyundai-manufactured circuit breakers were on the Lloyd’s Register Type Approved List, however when no.2 was due to be replaced after the fire it was found that such circuit breakers were no longer listed. The Marine Incident Investigation Unit contacted the Lloyd’s Register Type Approval Department in Croydon, UK, to establish why Hyundai-manufactured circuit breakers had apparently been removed from the type approval list.
