Fatal boiler explosion after chemical cleaning

Official report: edited from MAIB Safety Digest 2/2008, Case 7

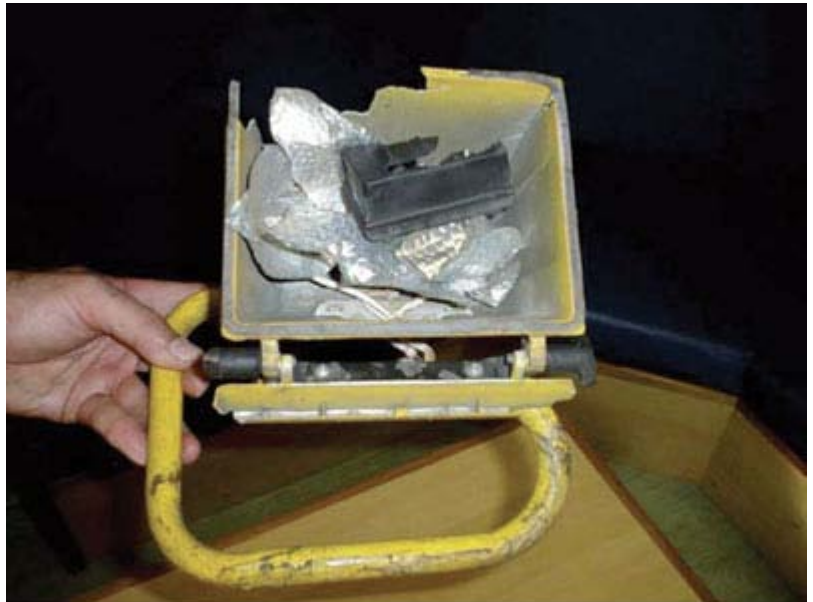
Figure 2: remains of the non-intrinsically safe halogen lamp that caused the explosion

At about 21:45 the steam drum door was opened, and as the contractors pushed the door into the drum there was a noticeable suction as the seal was broken. The workers also moved a non-intrinsically safe halogen lamp to a handrail near to the steam drum. At 22:00, both the cleaning experts approached the steam drum door. No tests were conducted to check the steam drum atmosphere for either toxic or flammable gases. The UK expert picked up the halogen lamp and placed it just inside the steam drum. The Danish expert saw a small flame or spark, and an explosion immediately followed.

1. Accumulation of hydrogen gas in the steam drum, which evolved during the cleaning procedure. As the steam drum door was opened, the air combined with the hydrogen to create a mixture that was within the hydrogen's wide explosive limits;
2. Insufficient arrangements were made to ventilate the boiler and so release the evolved gases to atmosphere. Had the boiler been properly ventilated, the hydrogen build up would not have occurred;
3. The introduction of the hot halogen lamp into the untested, confined space of the steam drum, which was known to have possibly contained flammable gases, was a serious error of judgment.

6. Only intrinsically safe lighting systems shall be used in confined spaces.
