Technical eNewsletter

Oil contamination of marine boilers

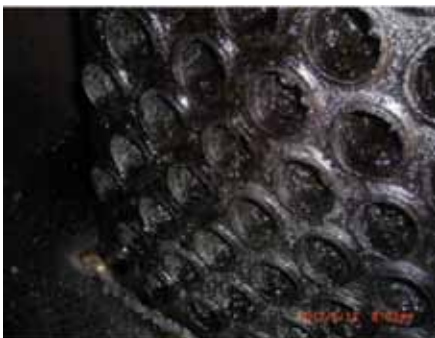
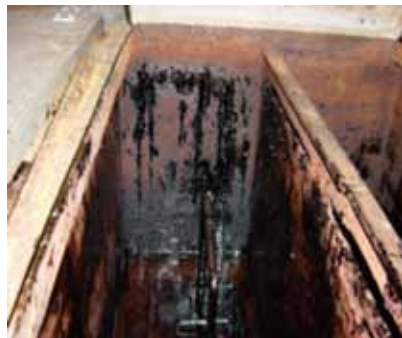
Severe oil contamination leads to a collapse of the heat transfer rate through the boiler steel, contributing to a higher metal temperature than the design value.

With reference to the illustrations (next page), even an oil film or deposit as thin as 0.5 mm on the water side can easily increase the metal temperature on the furnace side (T₂) from the design value of 250 deg C to well above 600 deg C under normal operating conditions on an auxiliary boiler rated at 7 bar (g). This has a domino effect of exponentially reducing

the yield strength of the material until the pressure parts subjected to active heat transfer fail.

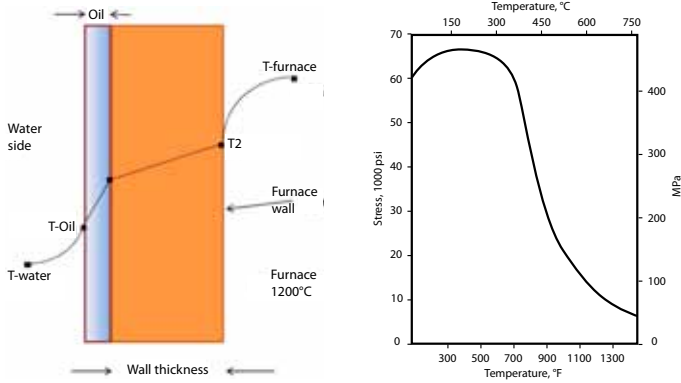
Temperature gradient across the material thickness

In cases where the reduction in the strength does not lead to immediate failure, the boiler steel can still be subjected to a time-dependent creep zone that is hard to evaluate (if above 380 deg C) unless catered to at the design stage by alloying.

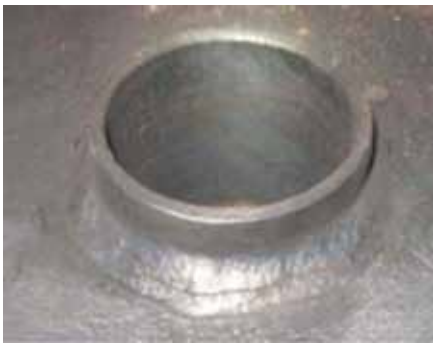
In the case of exhaust gas water tube boilers with an extended surface area that forms part of the steam generation system by forced circulation, this may in the worst cases lead to soot fires due to a lack of heat transfer from the gas side and rise in the metal temperatures due to the uncooled boundaries. Smoke tube exhaust gas boilers are prone to cracks on the tube terminations (see image below) due to differential expansion of the overheated tubes with respect to the shell.
