RMS TITANIC CASE STUDY

Introduction

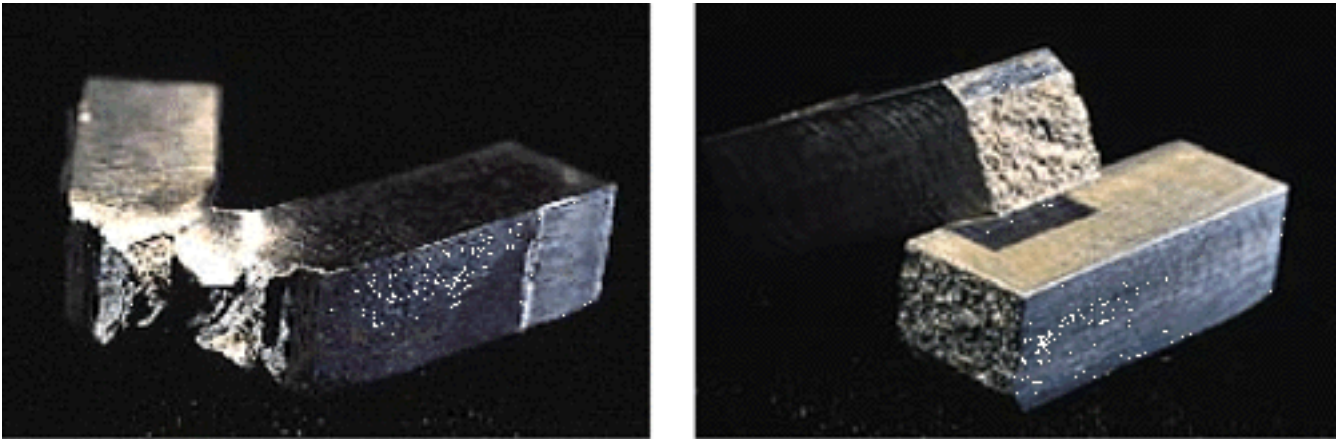
Pictures of the two coupons following the Charpy test are shown in Figure 1. What the test showed, and the readout confirmed, is the brittleness of the Titanic's hull steel. When the Titanic struck the iceberg, the hull plates did not deform. They fractured.

Figure 1. Results of the Charpy test for modern steel and Titanic steel. When a pendulum struck the modern steel, on the left, with a large force, the sample bent without breaking into pieces; it was ductile. Under the same impact loading, the Titanic steel, on the right, was extremely brittle; it broke in two pieces with little deformation.

A microstructural analysis of the Titanic steel also showed the plausibility of brittle fracture of the hull steel. The test showed high levels of both oxygen and sulphur, which implies that the steel was semi-kilned low carbon steel, made using the open-hearth process. High oxygen content leads to an increased ductile-to-brittle transition temperature, which was determined as 25 to 35° C for the Titanic steel. Most modern steels would need to be chilled below -60°C before they exhibited similar behavior.

High sulphur content increases the brittleness of steel by disrupting the grain structure. The sulphur combines with magnesium in the steel to form stringers of magnesium sulphide, which act as "highways" for crack propagation. Although most of the steel used for shipbuilding in the early 1900s had a relatively high sulphur content, the Titanic's steel was high even for the times.
