Stabiliser fins

Passenger/Ro-Ro ship

Stabiliser fin failure

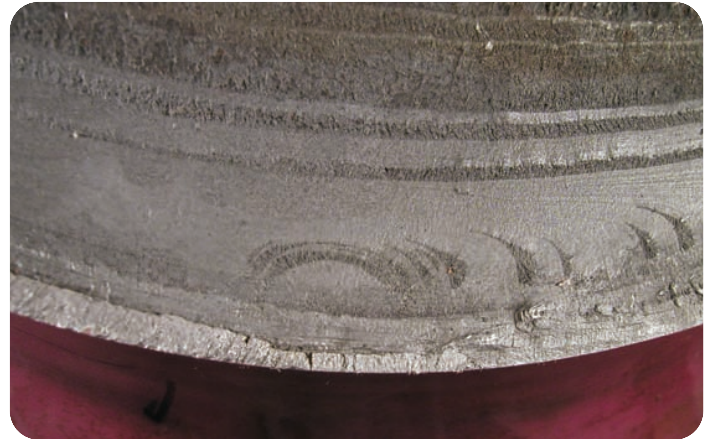
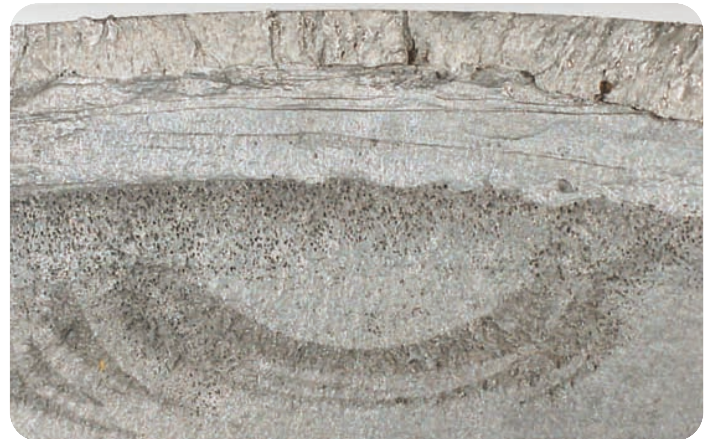
By examining the remaining part of the fatigued stabiliser stock at the Lloyd's Register Materials and NDE Laboratory it was found that a fatigue crack had grown from a single initiation point, 5 mm below the shaft surface, in the fusion zone between a weld and the base material. Welded regions often show characteristic non-uniformities and inclusions at the base material interface. It was also found that no heat treatment had been undertaken to eliminate residual stresses. These residual stresses can often encourage crack growth.

shaft due to roll of the ship in service. The low factor of safety was apparent from the fatigue pattern as the fatigue crack had propagated for only 15% of the shaft diameter before rapid brittle fracture finally occurred.

During the initial stages of crack growth there were three distinct bands of relatively slow propagation interspersed with two narrow bands of more rapid propagation. These changes in crack growth rate indicated significant changes in service loading, such as loading induced by especially rough sea conditions.

Recommendations were made that the stabiliser stocks on sister vessels should be examined visually and by non-destructive testing for the presence of cracks. Recommendations were also given to fitting shafts with an increased operating margin against imposed bending loads.
