Gear scuffing

**SUBJECT VESSEL
TYPE**
LNG Carrier

ISSUE
Scuffing of the main
reduction gearing

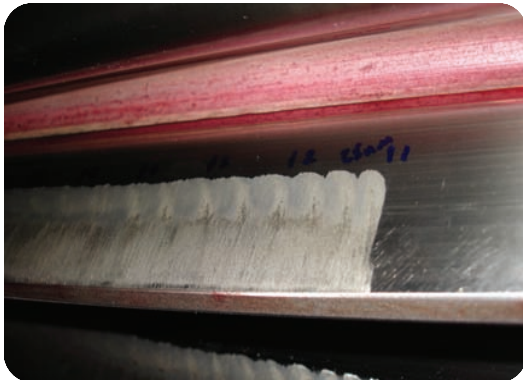
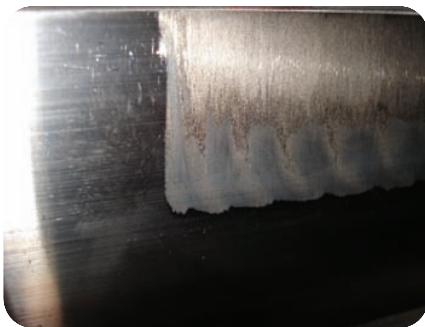
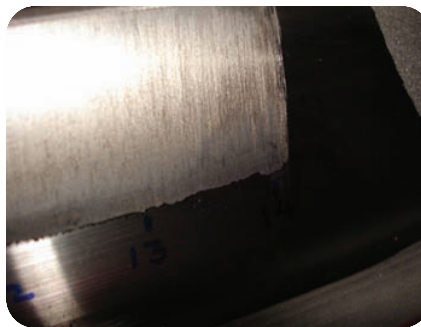
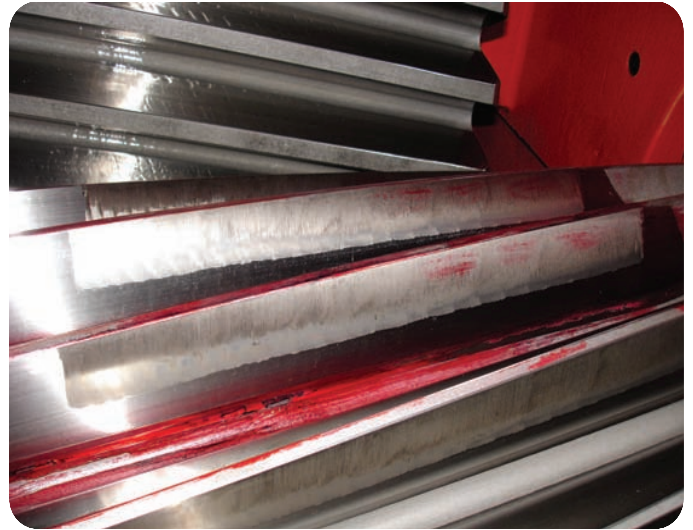
Severe scuffing damage occurred on the teeth of the two input pinions and main wheel of the main propulsion gearing during trials of a newly built diesel electric LNG carrier. The propulsion system consists of twin electric motors driving a single output main propulsion shaft and fixed pitch propeller through single reduction, single-helix gears. Lloyd's Register Technical Investigations (TI) was asked to attend onboard at the newbuilding yard to inspect the tooth flank damage and assist with the failure investigation.

Failure of the gears was traced from trial records to occurring during a rapid acceleration test. In this test, the propulsion plant was accelerated from stationary to full away in a little over eleven minutes.

The scuffing damage was due to a breakdown of the elasto-hydrodynamic oil film which should normally be present between mating gear teeth. The breakdown resulted from a combination of the selection of the pinion gear tooth-end design and the rapid rate of torque input to the pinion gears from the electric propulsion motors. It was considered likely that the damage was initiated at the starboard mesh and then transferred to the port mesh in way of the main wheel.

The damaged pinion gears were returned to the gearing manufacturer for remedial

machining including design modifications to the gear tooth flank. The main wheel tooth flanks were polished in-situ.

Following repair, the reduction gearing successfully completed sea trials. This was achieved by modifying the pinions helix correction and end relief. The propulsion electric motor speed-torque characteristics had also been modified to reduce the initial rate of torque delivery to the pinion gears.
