Casualty Information

Information from DNV to the maritime industry No. 2-11 April 2011

Severe bearing damage in the main engine due to spark erosion

Ship type: Tanker for oil Size: 70,000 dwt Year built: 2004

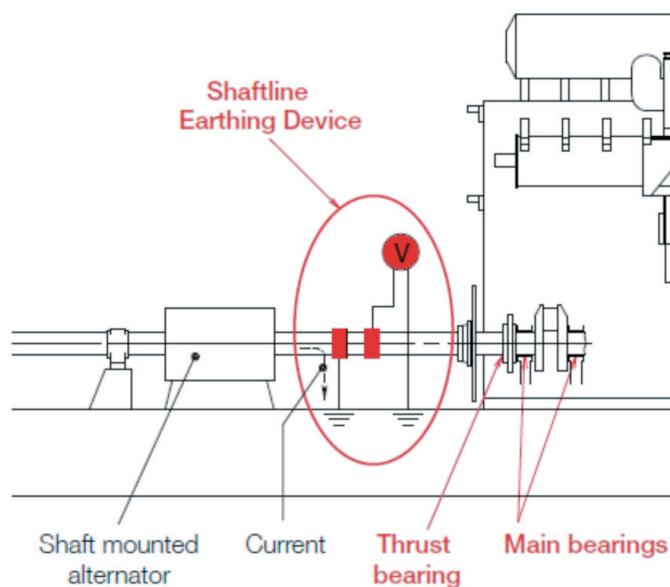
Figure 1: Illustration of shaftline earthing device arrangement (courtesy MAN Diesel & Turbo)

It was concluded that the extensive wear of one of the main bearings of the main engine in the incident discussed was due to spark erosion. This is most likely due to the shaftline earthing device not working as intended. In this situation, the electric potential between the crankshaft journal and the bedframe caused electric sparks to appear between the shaft and the bearing lining, which in turn caused extensive wear of the lining in a short space of time. Finally, metal to metal contact in the bearing caused the overheating, oil mist and emergency shutdown.

- Earthing of the propeller shaft (electrical grounding) is a present DNV Rule requirement for all newbuildings. If not already installed, it is also recommended for all other vessels (also for vessels without ICCP). It is also best practice to use two earthing devices, one for the grounding and one for the monitoring of the potential difference (mV). The earthing device is best placed close to the main engine to achieve an easy access and a dry environment.

- Regular maintenance of the shaftline earthing device is important, especially if it is mounted at the far aft end of the shaft and in a moist environment. Typical maintenance includes ensuring slip rings with a sufficient silver layer, brushes that are not worn out, appropriate contact between the shaft and slip rings and general cleanliness.
