Accident Report

Ammonia Leak

San Nikunau

REPORT NO.: 05 3749

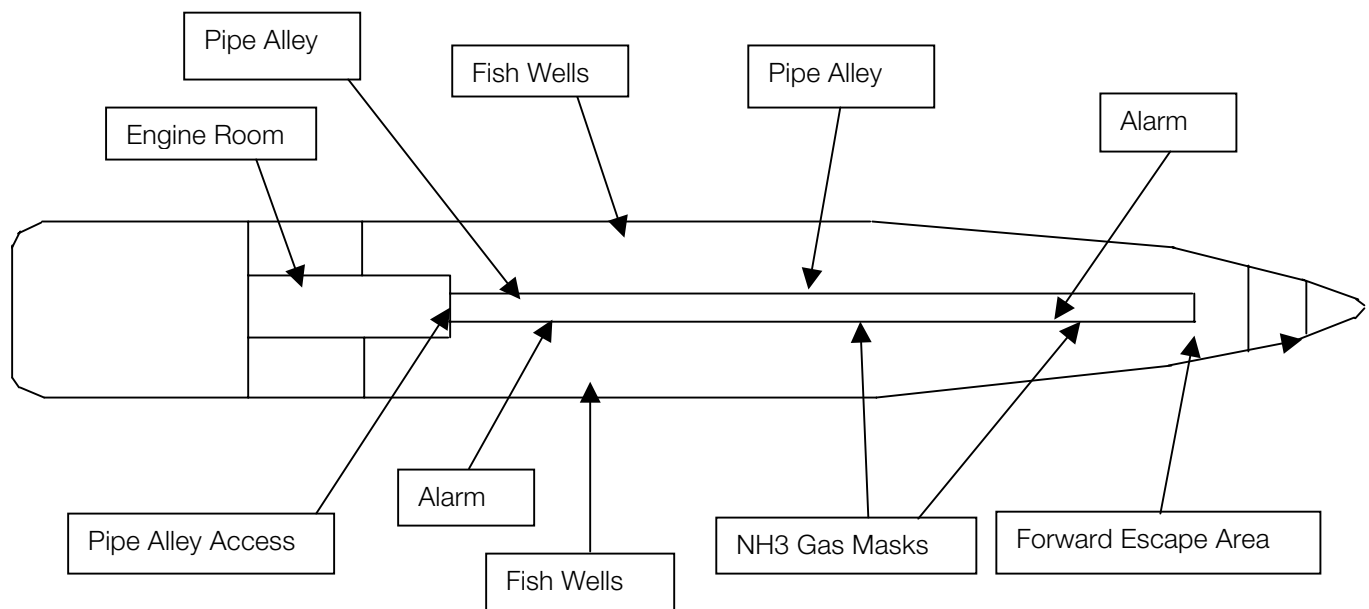
The pipe alley runs along the duct keel from the engine room to the No. 1 fish well in the bow section. Access to the pipe alley is from the engine room. At the forward end there is an escape exit up onto the main deck. A catwalk running the full length of the alley separates it to an upper and lower section. Three receiver units in the alley contain ammonia for refrigerating fish wells. Each unit is capable of holding 1500 litres. During operation, one unit is kept in reserve. At the time of the accident the units were at 75% capacity. The pipe that failed was on the port side of the catwalk behind large condenser pipes. Heavy rust was found at the section that failed. Behind the bulkheads on both sides of the alley are fish wells (See Figures 1 & 2 - Diagram of below main deck and refrigeration system (not to scale) plus photograph of pipe alley from position of leak)

Figure 1
San Nikunau – Below Maindeck Diagram
(not to scale)

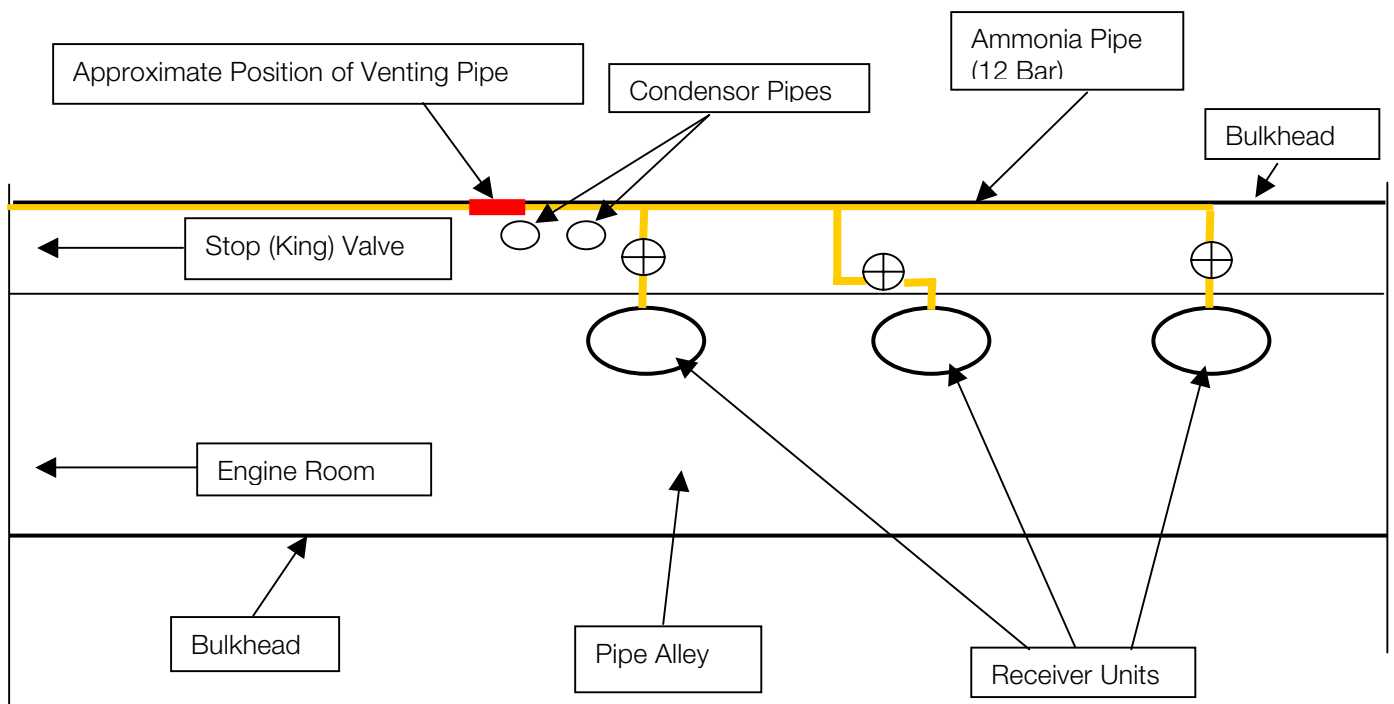
Shortly before 0215 hours, three crew including the Chief Engineer, were working in the pipe alley to reduce brine temperatures when a small ammonia gas leak was detected from a rusted section of the discharge line from the receiver. The Chief Engineer instructed the Assistant Engineer and Oiler to close valves to isolate the section of pipe whilst he went under the catwalk to check for further leaks. As the valves were being closed, but before the pipe could be isolated, it commenced venting a large quantity of ammonia. The Engineer ordered the crew to evacuate the pipe alley. As he left, he closed the king valves, however, the discharge continued as the venting pip was not fully isolated. The two crew who were forward of the leak escaped by running aft, through the venting ammonia, and in so doing sustained ammonia burns to their legs and arms. *(See Figures 1 & 2 - Photographs of the pipe alley showing area where ammonia vented & pipe that failed).*

Figure 2
Section of Pipe Alley where Ammonia was vented
(not to scale)

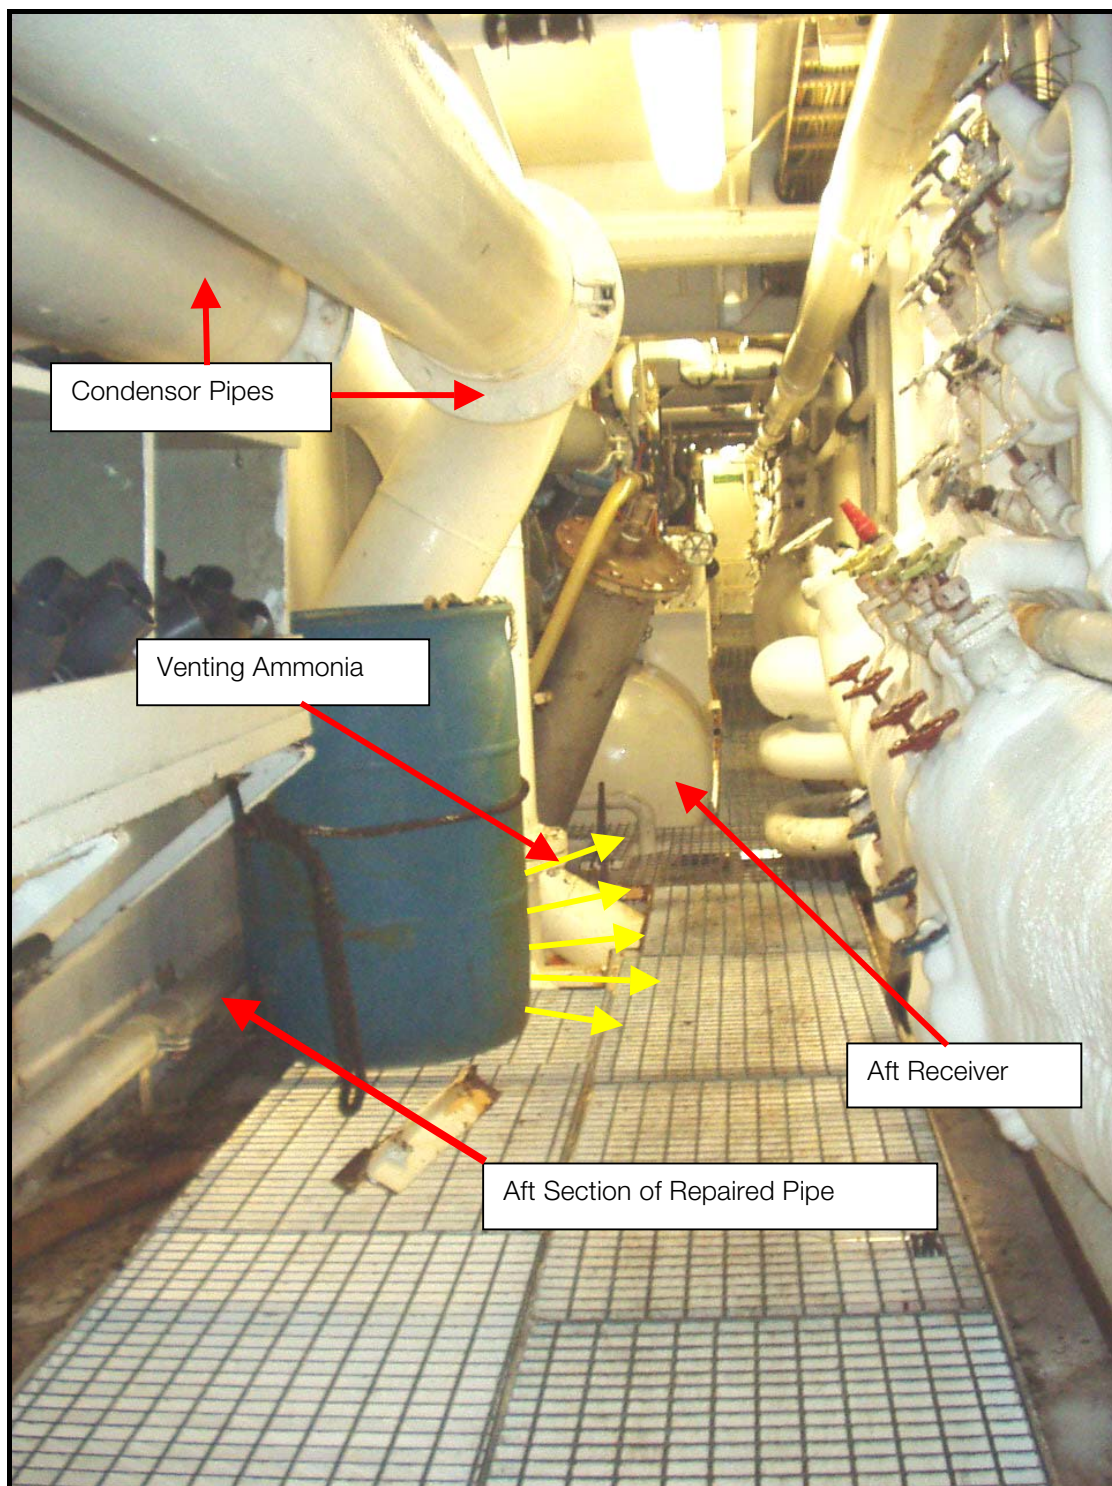
Photograph 2

The pipe that failed was the discharge line from the receiver. It was under continual pressure of 12 atmospheres (12 bar). It can only be closed down when the entire system is shut down (See *Photographs 2 & 3 - Replaced section of pipe viewed from aft and forward*).

The sudden failure of the discharge pipe allowing a large quantity of ammonia to vent may have been caused by the rapid drop in temperature in the area of the initial leak. When the leak first occurred the effect of expanding gas might have chilled the adjacent material thus altering its physical properties causing the failure to occur over a larger area.

- Given the serious danger ammonia poses, specific drills for ammonia leaks should be mandatory on fishing vessels carrying ammonia.
- The section of pipe that failed was heavily rusted.

- The pipe that failed was not readily visible due to it being behind large condenser pipes. It is likely that the line was not visually inspected on a regular basis because of its situation.

1. A compressor be carried on board to ensure BA bottles can be refilled.
2. The company put in place a scheduled inspection system to ensure all ammonia pipes are inspected every 6 months and replaced if required. *At the time this report was being compiled sections of piping had been marked for replacement.*

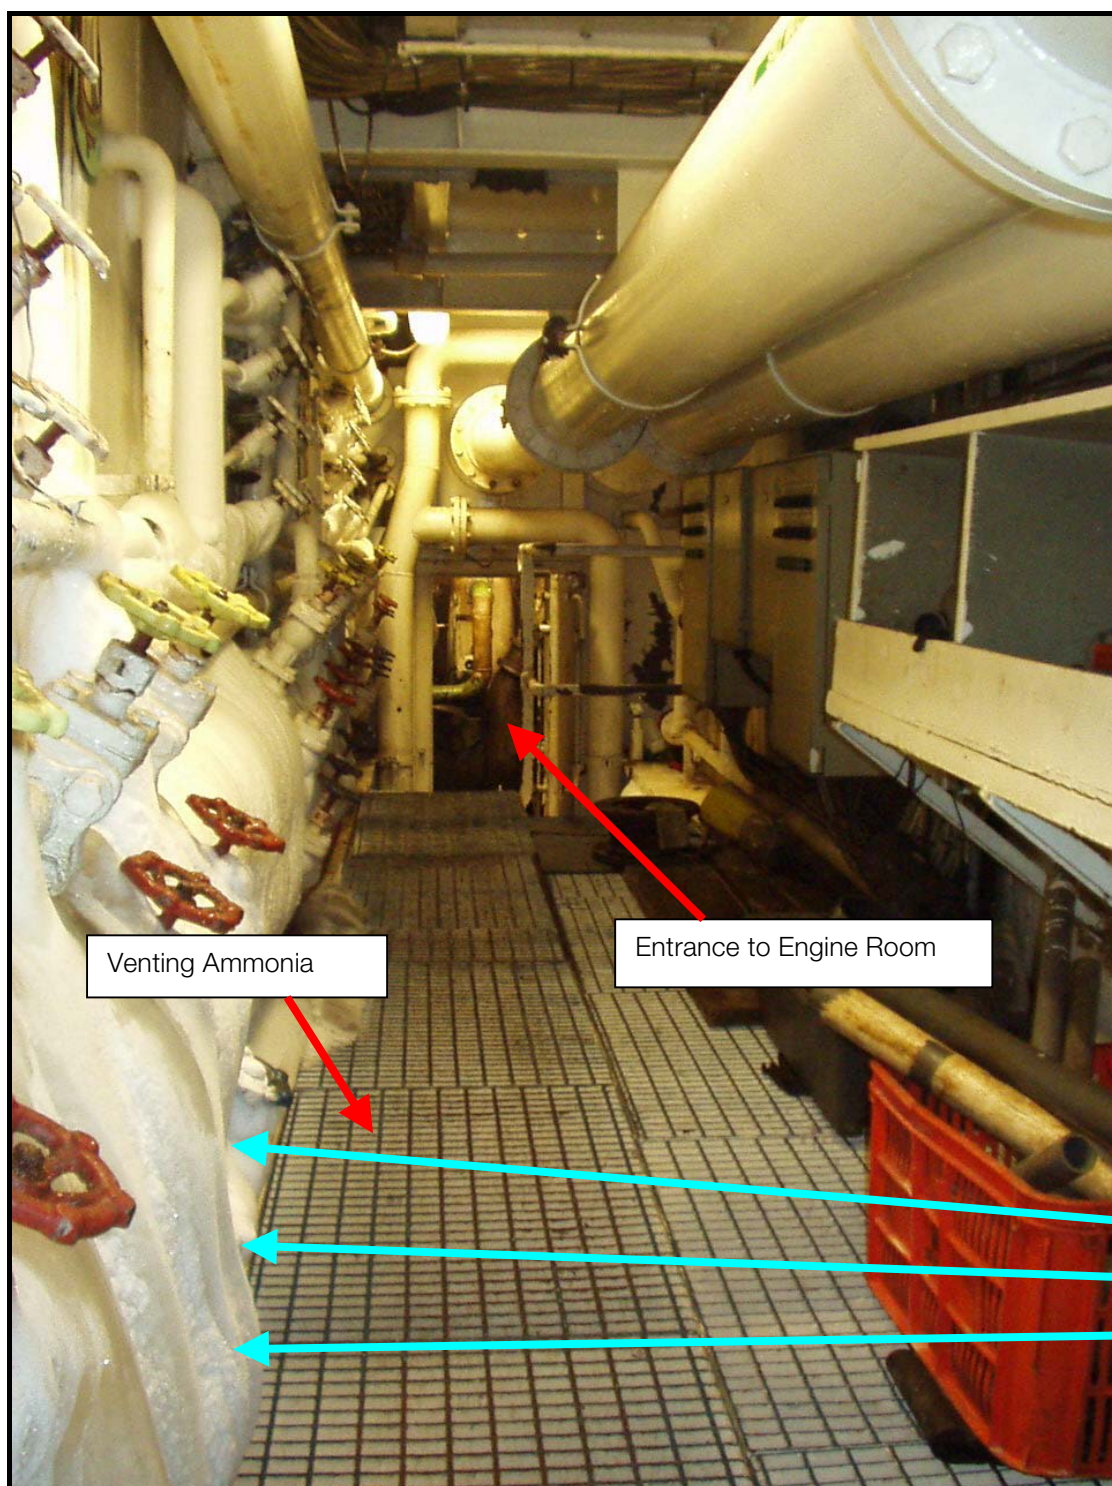
The three crew exited the pipe alley by running aft to the engine room (See *Photograph 4*).

The pipe alley is ventilated from positive pressure exerted by the engine room blowers. This forces air into the alley from the engine room (*See Photograph 4 - Engine room entrance viewed from position of leak*).

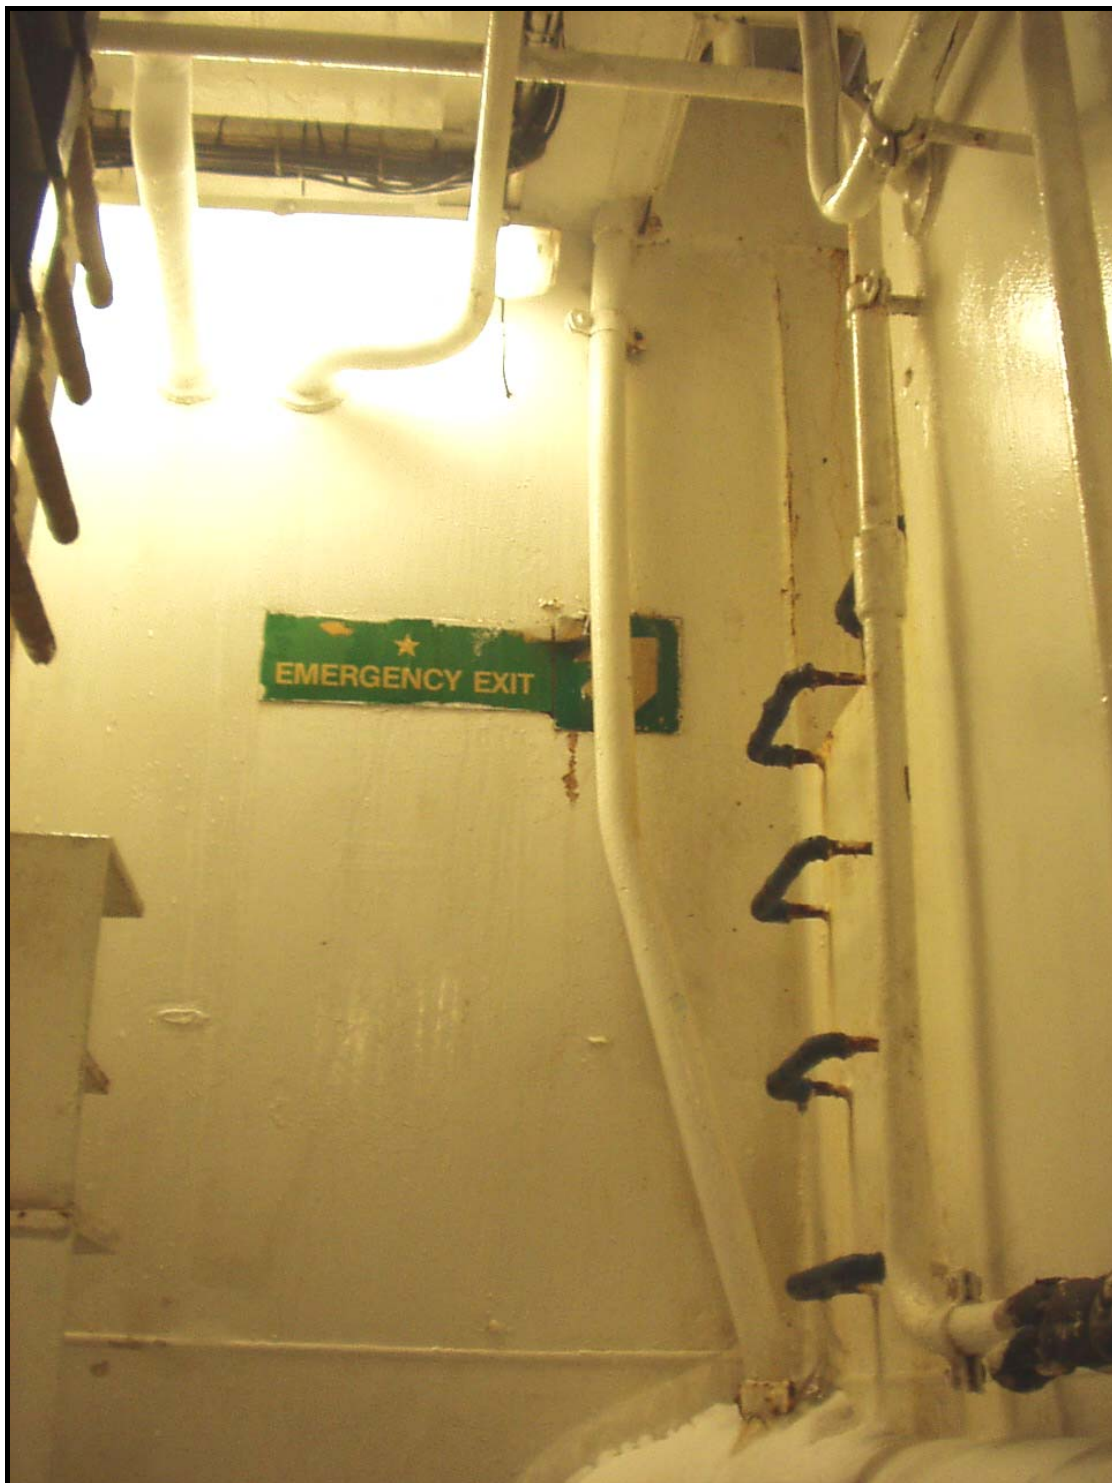
Due to the positive pressure from the aft section of the alley, the ammonia expanded forward from the venting point. For this reason the crew escaped via the engine room. They knew that after passing through the venting ammonia they could breathe safely. The other option was to run forward, hopefully in advance of the expanding ammonia, and escape up the ladder at the forward end of the pipe alley (*See Photograph 6 - Emergency exit and escape rungs*).
