Report from the Division for Investigation of Maritime Accidents

Engine room fire – MAERSK MASTER

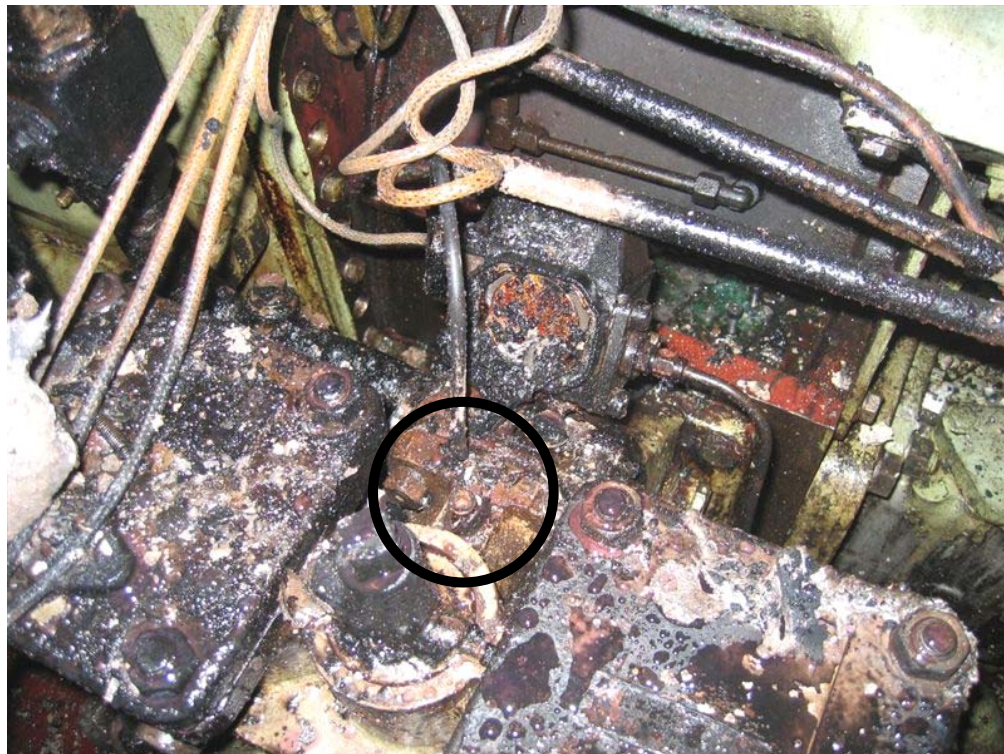
One of the pipe connections for a differential pressure gauge mounted on the duplex fuel filter for main engine 1 had failed. This had caused the diesel oil to leak at high pressure. The diesel oil was then deflected onto the surroundings and further to hot surfaces where it was finally ignited. See picture below.

Failed connection for differential pressure gauge: By courtesy of Maersk Supply Service

- All filters for fuel and lubrication oils have been shielded by custom made covers.
- Lubrication oil coolers close to hot surfaces have been shielded by custom made covers.

- Anti-leak shut of valves have been installed by instruments and hook-ups at risk in case of leaking pipes.
- The power management system has been altered such that the emergency generator will be automatically connected to the main switchboard when started.
