**CRANKCASE EXPLOSION
CASUALTY INVESTIGATION**

BRITISH VALOUR - OFFSHORE BERMUDA

23.03hrs (GMT) 18 MARCH 2001

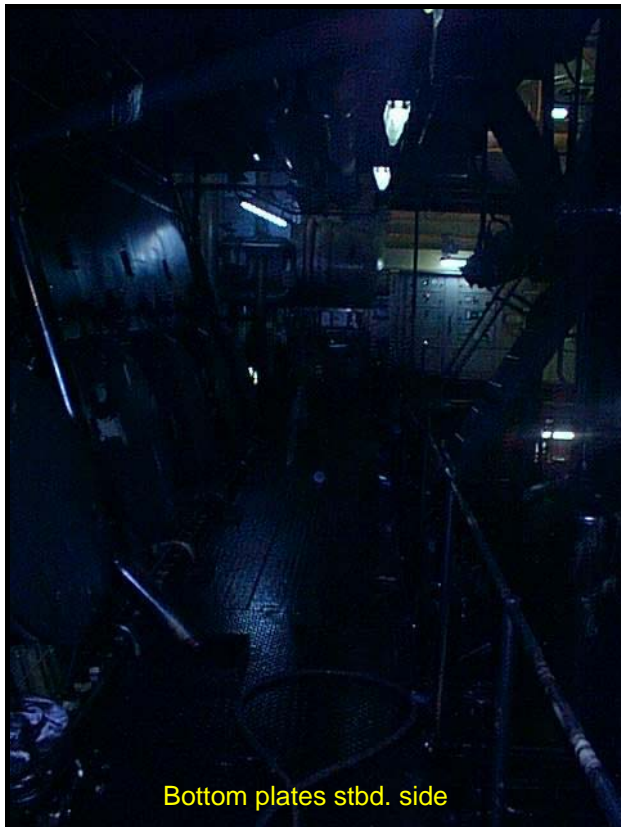
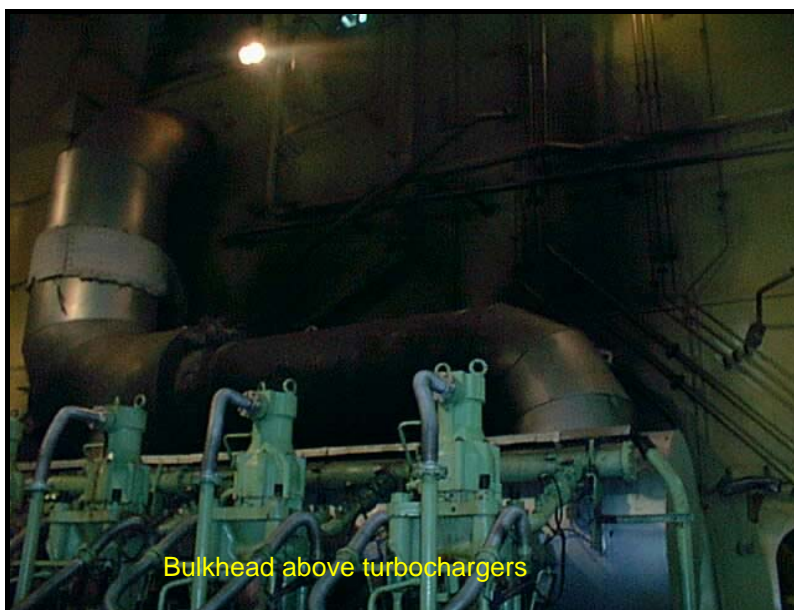
- 2.1 The engineroom was smoke/soot blackened on the starboard side, deck plates around the cylinder head area were distorted and dislodged from their original location, thermoplastic diffusers on fluorescent light fittings had melted sufficiently to flow easily under gravity and their own weight, physical contact damage was apparent in a number of locations.

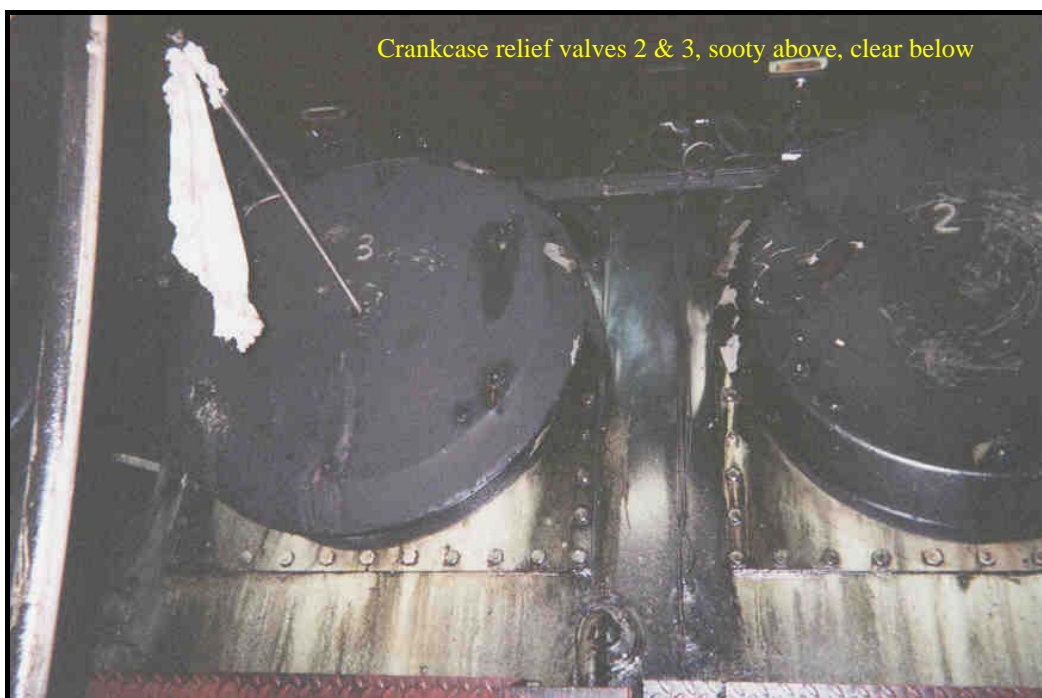
- 2.4 Ships staff performed a crankcase inspection, bearings and running surfaces were checked but nothing immediately obvious was discovered, a very small amount of 'squeezed' bearing white metal was found on top of the oil sump near no.8 main bearing, but not enough to raise suspicion of a hot spot. Engine monitoring systems indicated no bearing high temperature alarms initiated before or after the event and discoloration on internal surfaces was negligible to none existent.
- 2.5 External signs were that all eight crankcase explosion relief valves (located on the starboard side of the engine) had lifted, nos. 2, 5 and 6 were found to have incorrectly seated after closing under pressure from their return springs. Additionally two of the sealing rubber 'o' rings had become dislodged from their seats.

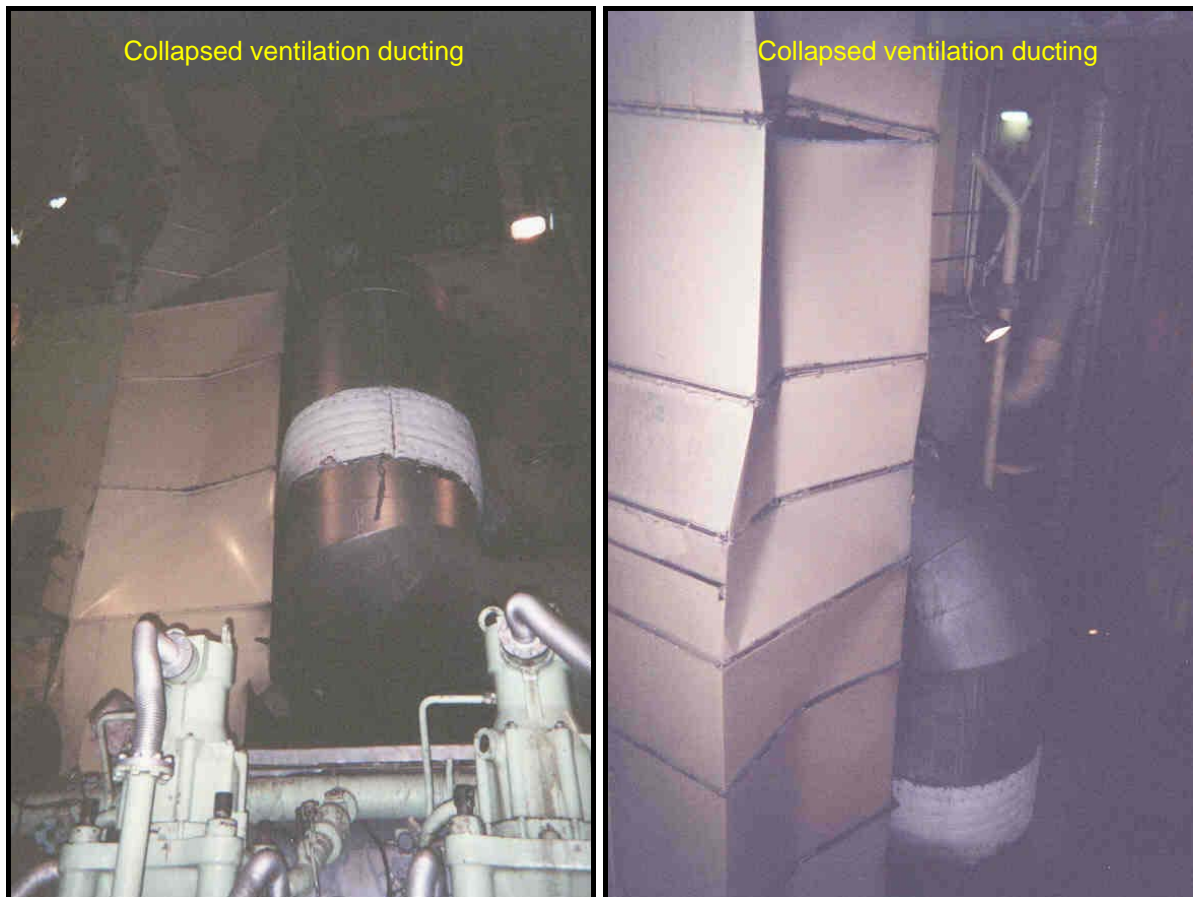
- 2.11 Paint blistering/lifting damage was evident on thin plate ducting and pipework in the area of the starboard side of the engine and alarm monitoring connection boxes outboard of the turbochargers were damaged by contact and/or melted by excessive heat.
- 2.12 The control room door wire reinforced glass was blown through into the control room where shards of glass became embedded in adjacent woodwork. The workshop door was buckled and de-laminated. The spare gear store door was buckled through it's frame and blown off its hinges.

2.13 Engineroom ventilation ducting was significantly deformed, dislodged or collapsed and acoustic insulation was found littered over the after deck .

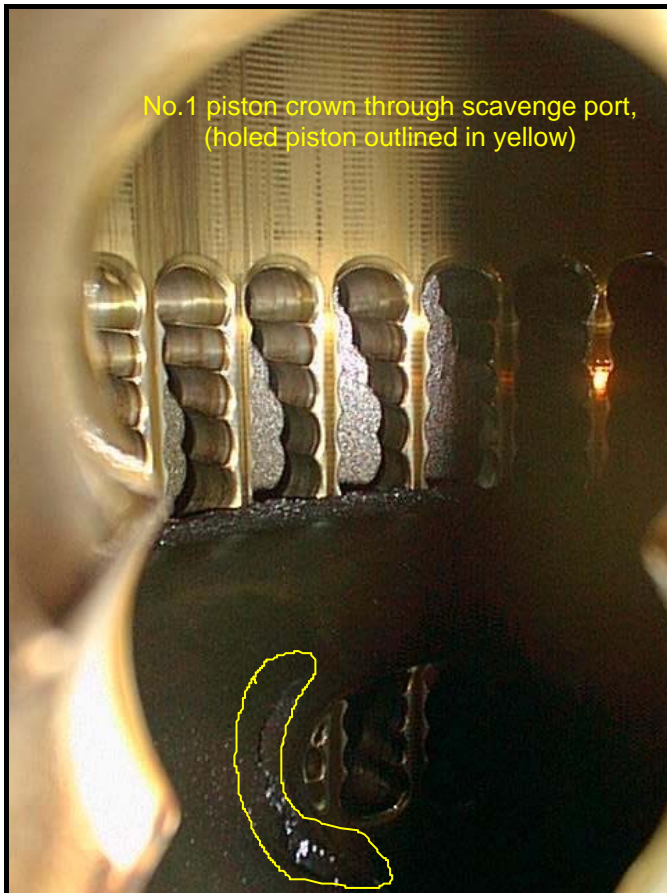
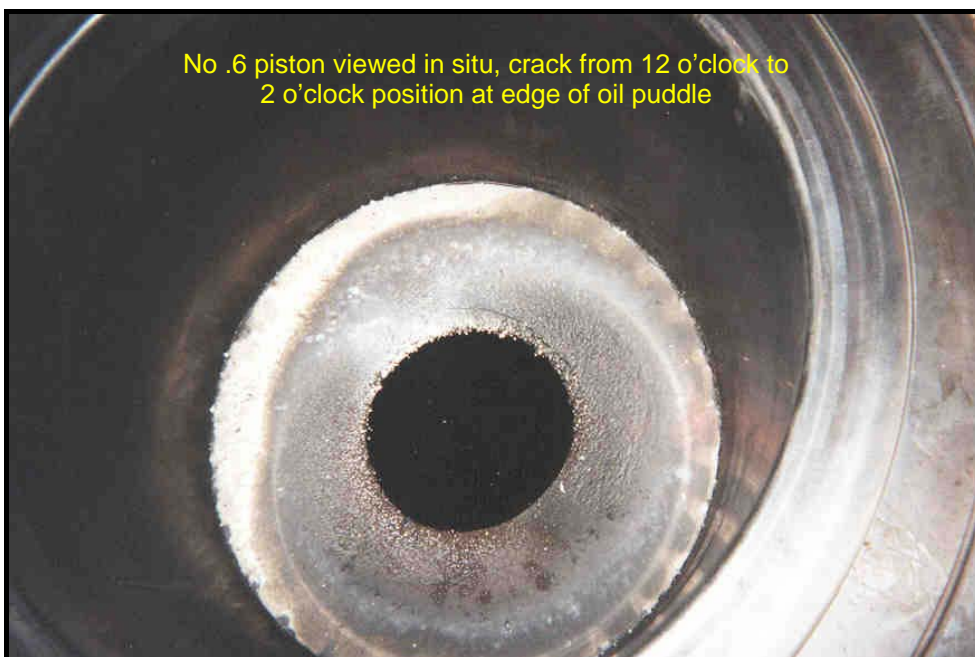
- 2.16 No.1 Piston crown was found to be cracked and holed which penetrated to the oil cooling space thereby allowing direct communication of the combustion space with the crankcase via the cooling oil passages and would indicate a probable initiation site.

- 4.1 The failure of no.1 unit, piston crown, allowed direct communication of the combustion chamber with the crankcase via the piston cooling oil passages. This allowed hot combustion gases to create and ignite a flammable oily mist mixture from the oil droplets normally present in the crankcase, causing a primary crankcase explosion.

- 4.3 Unusually large piston crown wear had occurred since overhaul in dry-dock in October 2000, the evidence gained indicates fuel impingement from poor atomisation which caused localised overheating and cooling oil breakdown on the internal surfaces of the crown and in turn increased the high temperature erosion in the areas of failure, ultimately leading to the mechanical failure of no.1 and no.6 piston crowns.

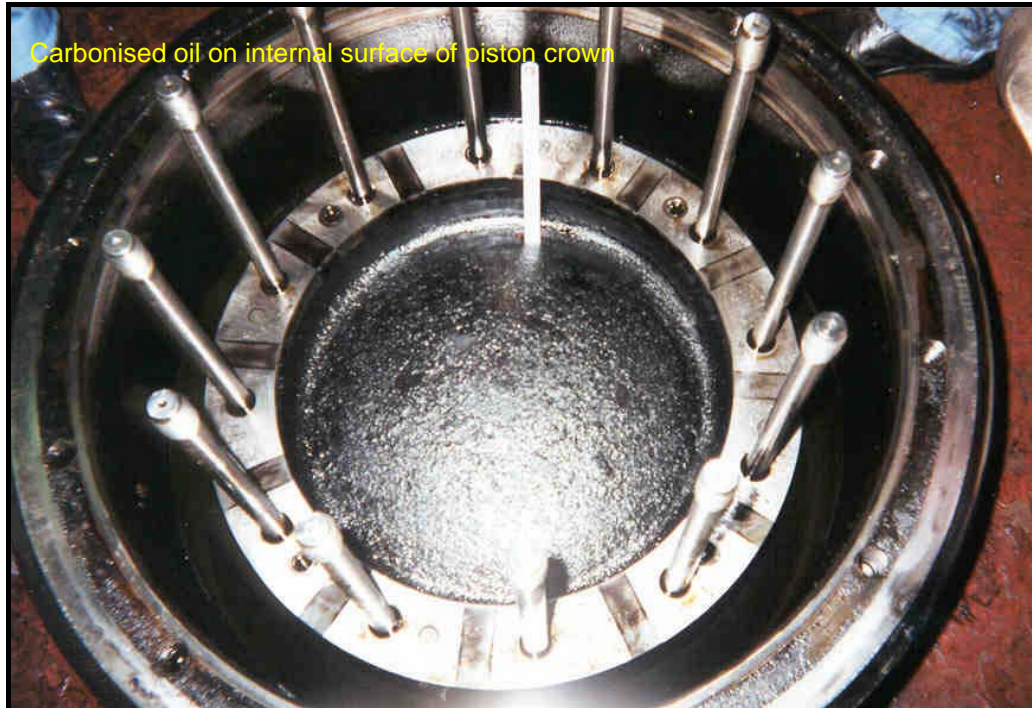
- 2.18 The scavenge space was found to be in a normal operating condition and showed no signs of internal fires.
- 2.19 Following dismantling, carbonised oil sludge was found to be coating the interior of the piston crowns.
