Intermediate bearing

Chemical Tanker

Failure of the intermediate shaft bearing

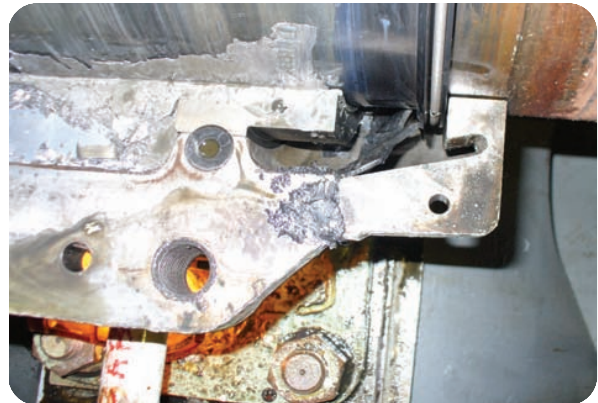
During a partially laden voyage a direct drive diesel powered Chemical Tanker suffered a severe failure of the intermediate shaft pedestal bearing. Significant wiping damage occurred to the bearing white metal surface requiring the ship to be towed to port for repair.

Following the failure bearing loads and shaft deflections were measured using the jack-up technique. The results revealed an unsatisfactory distribution of

load along the shafting system length. In particular it was found that the forward sternbush and the second aft engine bearing had insufficient downwards load. The second aft engine main bearing was considered to be at risk of fatigue damage.

Calculations revealed that the scope for improvement of the alignment conditions by adjustment of the intermediate bearing was limited. Loading of the engine second aft main bearing by fitting an upwards offset bearing shell was therefore recommended. Such adjustment would improve the loading on the engine bearing but would have negligible effect at the forward sternbush.

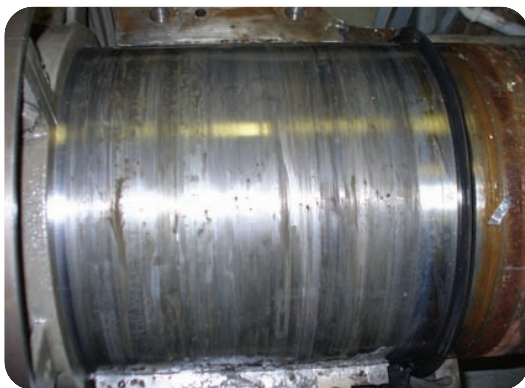
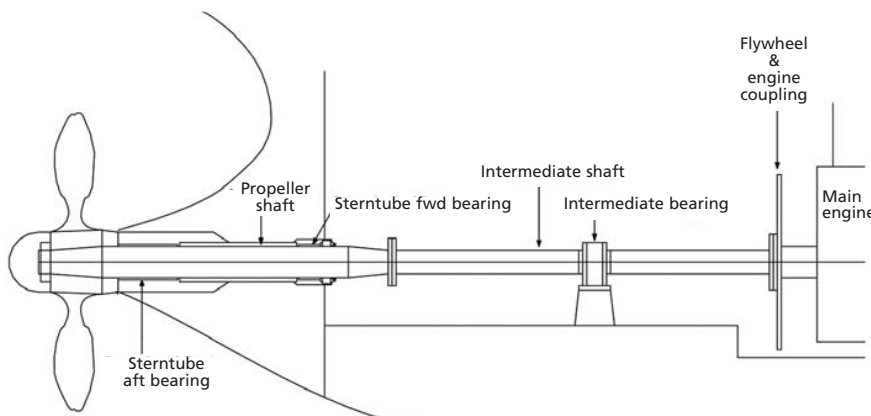
Following the completion of the refitting a sea trial was carried out where the helm was held over for prolonged periods of time putting strain on the shafting system. During these turns, the aft sternbush and intermediate bearing temperatures remained stable. Also there was no abnormal vibration found during increases and decreases in shaft speed.
