Simplex shaft seal

Fitting Shaft seals in service.

Split type stern tube (Ross-turnbull)

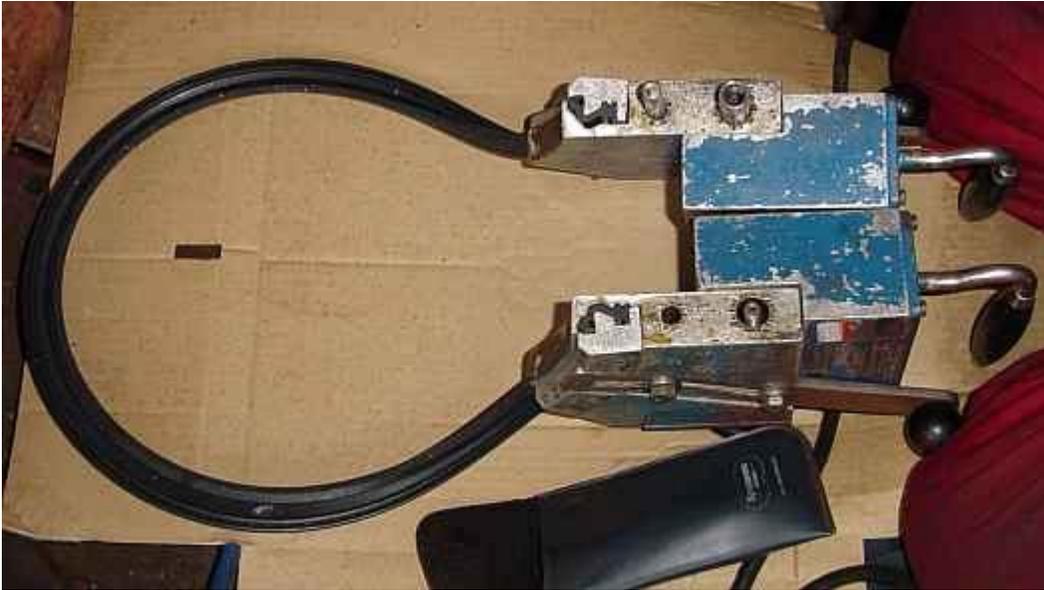
A precut seal is assembled into the vulcanising machine

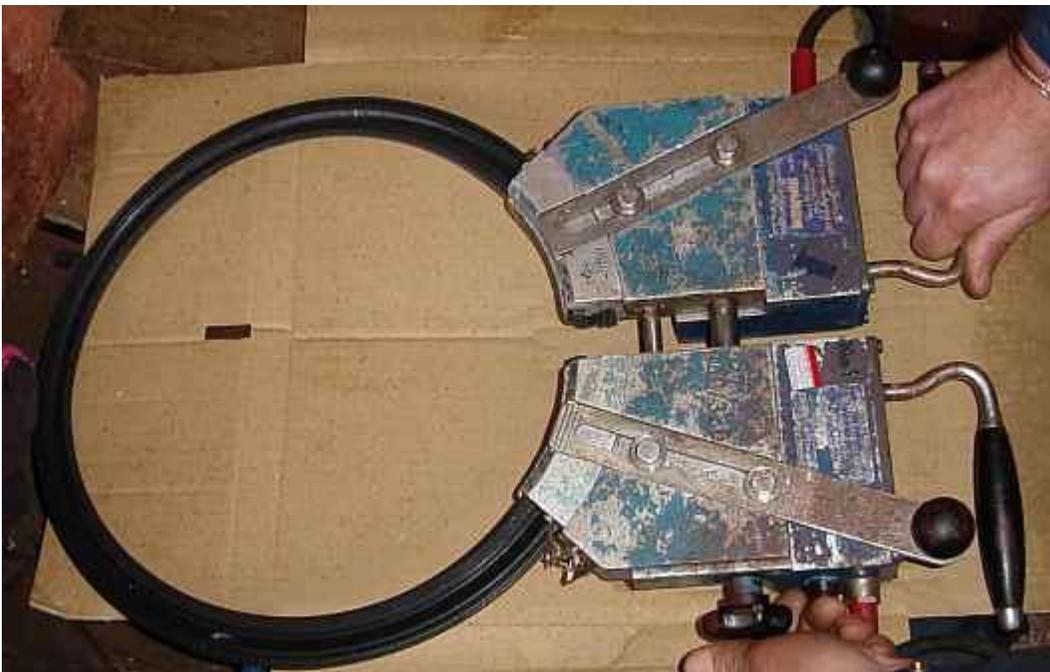
The vulcanising machine is then set up off the shaft and the position of the seal checked.

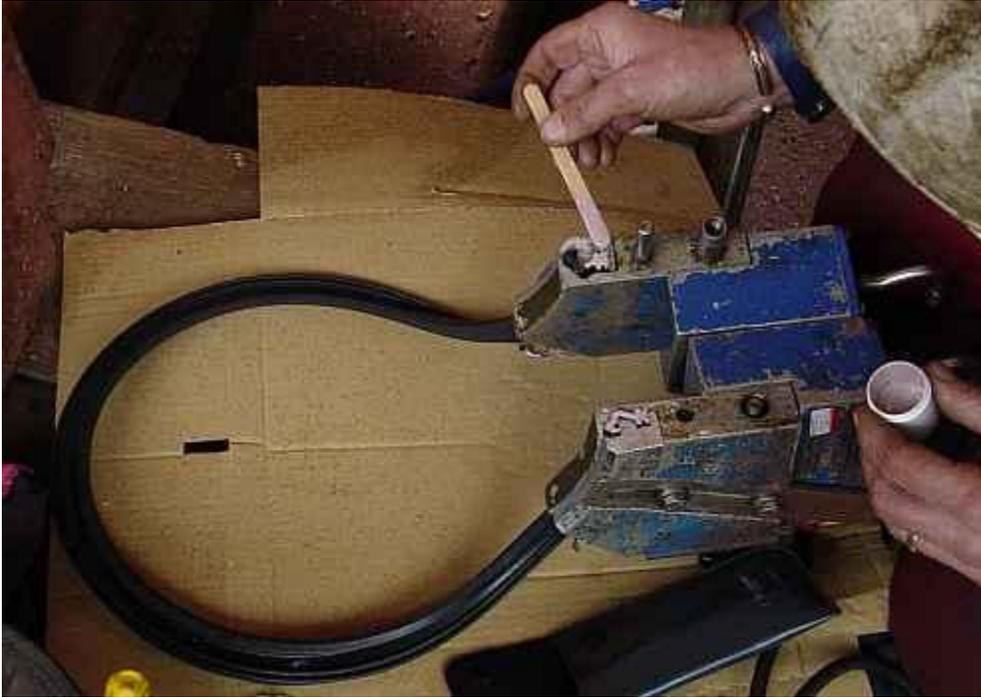
The vulcanising agent is mixed and applied to the seal ends.

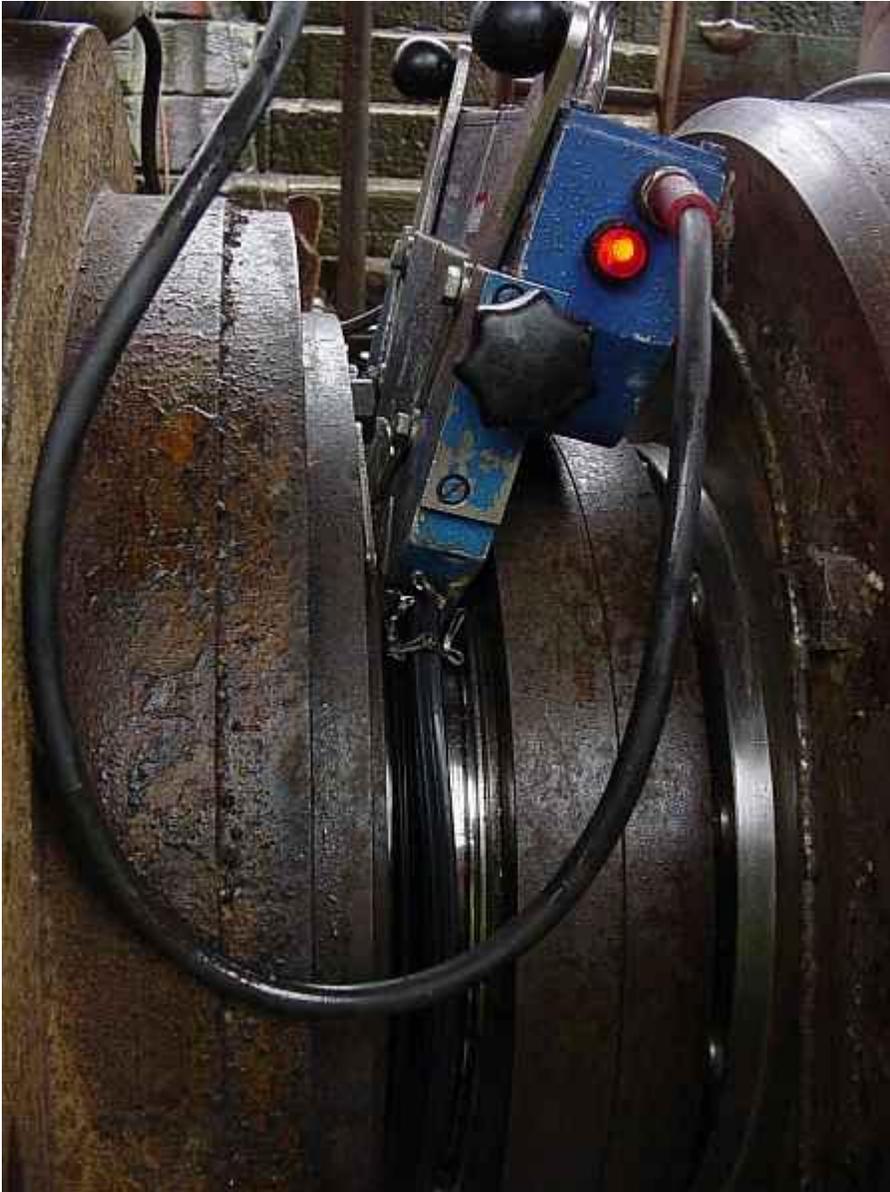
The vulcanising machine is then fitted to the shaft and connected to an electrical supply. A heater within the machine heats the seal to a predetermined temperature for a set time determined by ambient temperature, material type etc.
