**Departmental
investigation into
switchboard fire aboard
the Australian flag bulk
cement carrier Goliath at
Devonport, Tasmania on
23 August 1997**

investigation into the switchboard fire aboard the Australian flag
bulk cement carrier GOLIATH at Devenport Tasmania on 23 August 1997

Published: May 1997

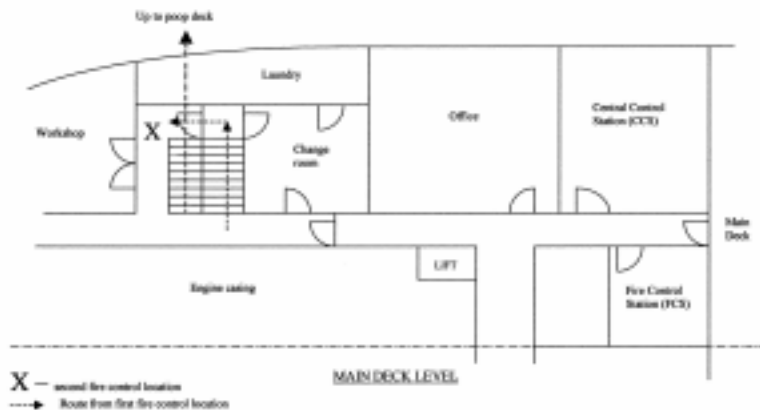
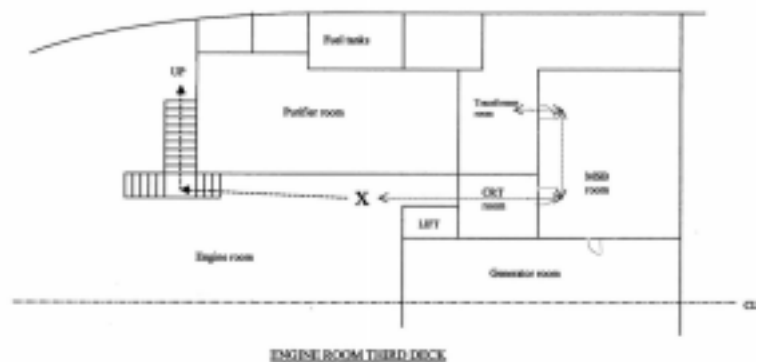
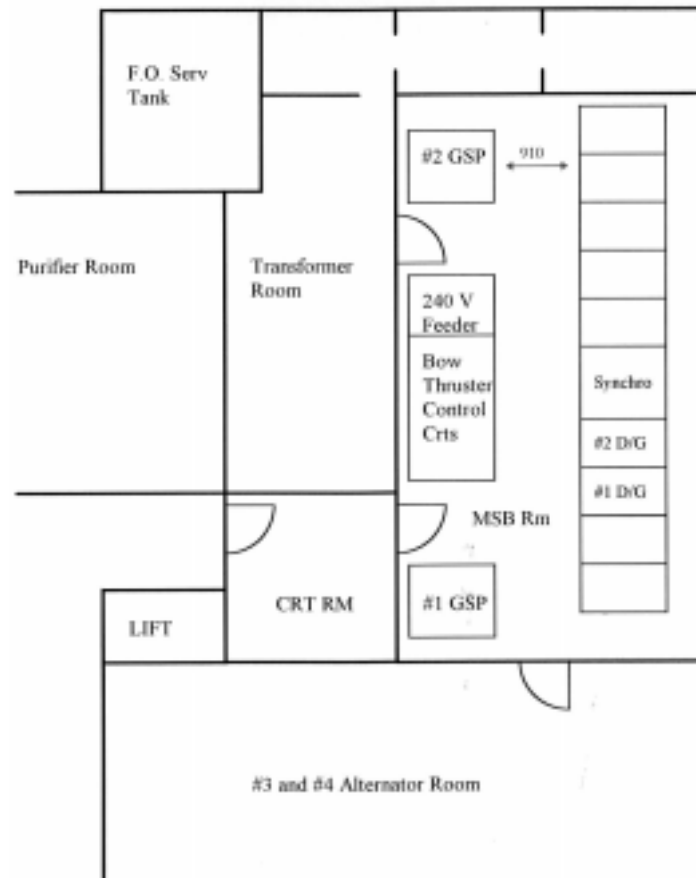
Sketch plans Port of main deck and Third deck

Sketch Plan forward port side of third deck

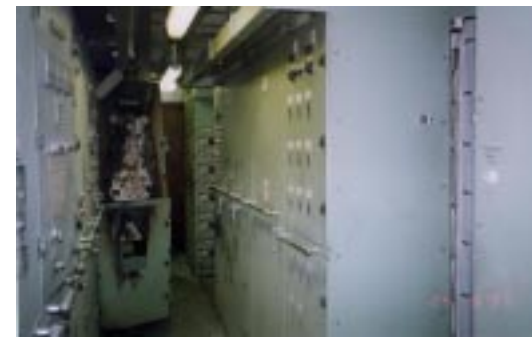
View of main switchboard room

The fire destroyed the circuit breaker and its associated control equipment. Heat damage had affected the adjacent cubicles either side of No.2 cubicle. These cubicles contained the circuit breaker for No.1 generator and the generator synchronising panel. Neither No.1 generator, nor No.2 generator, could be connected and the synchronising panel was inoperative. The remainder of the main switchboard had suffered some smoke damage. See photographs pages
