Stabiliser fins

Passenger/Ro-Ro ship

Stabiliser fin failure

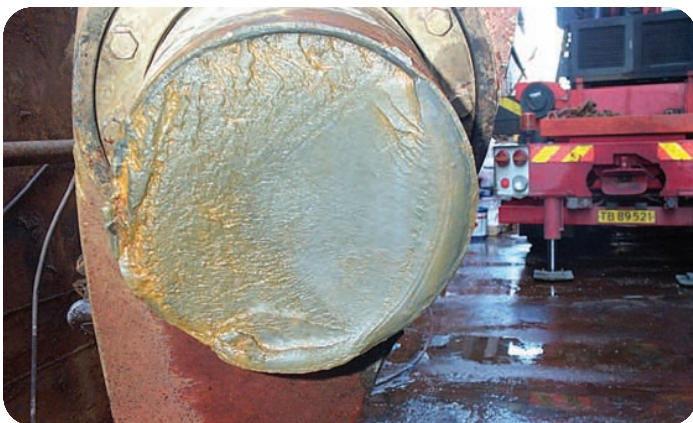
After three years in service one of the stabilisers was found to be missing, having failed due to fatigue some time before.

By examining the remaining part of the fatigued stabiliser stock at the Lloyd's Register Materials and NDE Laboratory it was found that a fatigue crack had grown from a single initiation point, 5 mm below the shaft surface, in the fusion zone between a weld and the base material. Welded regions often show characteristic non-uniformities and inclusions at the base material interface. It was also found that no heat treatment had been undertaken to eliminate residual stresses. These residual stresses can often encourage crack growth.

shaft due to roll of the ship in service. The low factor of safety was apparent from the fatigue pattern as the fatigue crack had propagated for only 15% of the shaft diameter before rapid brittle fracture finally occurred.

During the initial stages of crack growth there were three distinct bands of relatively slow propagation interspersed with two narrow bands of more rapid propagation. These changes in crack growth rate indicated significant changes in service loading, such as loading induced by especially rough sea conditions.

Recommendations were made that the stabiliser stocks on sister vessels should be examined visually and by non-destructive testing for the presence of cracks. Recommendations were also given to fitting shafts with an increased operating margin against imposed bending loads.
